**BAGHDAD POLICE COLLEGE  
BAGHDAD, IRAQ**

**SIGIR PA-06-078.2**

**SIGIR PA-06-079.2**

SUBJECT: Report on Project Assessments of Reconstruction Work Performed Under Task Orders 06 and 29 at the Baghdad Police College, Baghdad, Iraq (Report Numbers SIGIR PA-06-078.2 and PA-06-079.2)

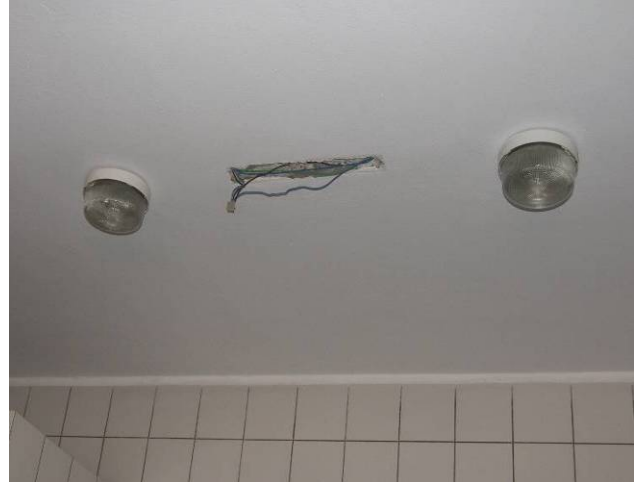
**Site Photo 158. Poor installation of light fixture**

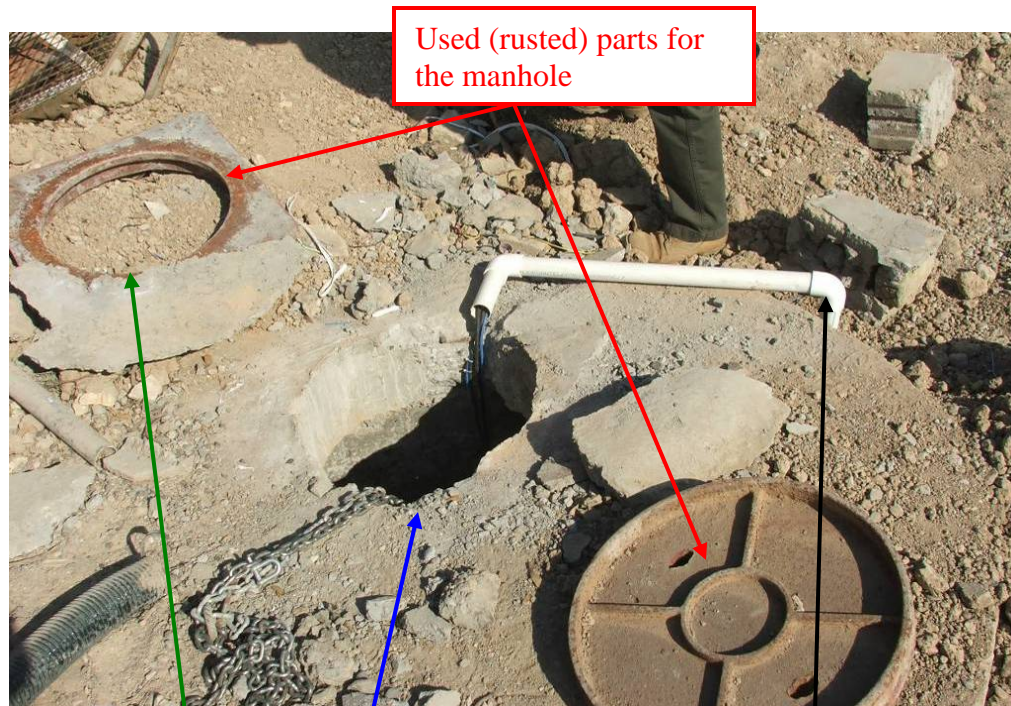
rudimentary and there was no protection for the control panel from the elements, such as extreme summertime heat, rain, wind, dust, and dirt (Site Photos 161 and 162). In addition, an elevated sewer manhole was created by pouring concrete on a used manhole ring over the existing hole (Site Photo 163). PVC pipe carrying the electrical wires was partially covered with concrete; however, the entire length of the PVC pipe was not covered, which leaves it vulnerable to damage from the elements (Site Photo 164).

Site Photo 163. Sewer manhole as of 1 December 2006

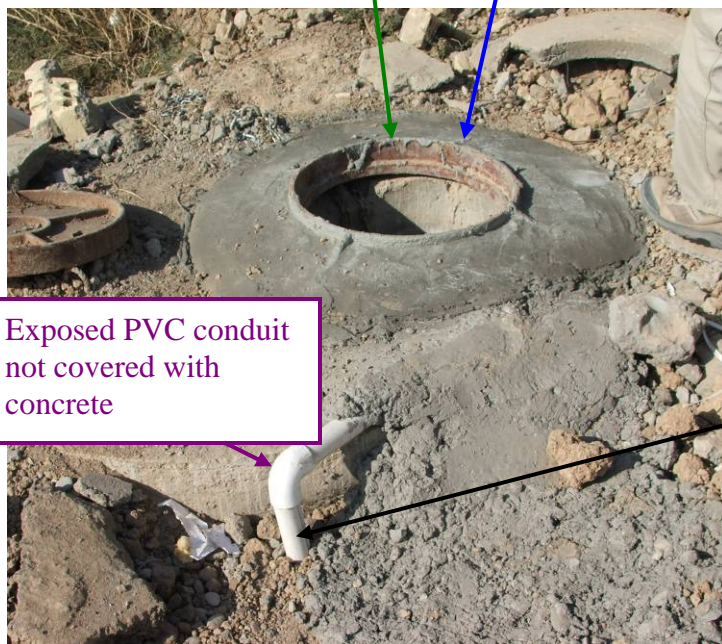
Site Photo 164. New elevated manhole as of 8 December 2006

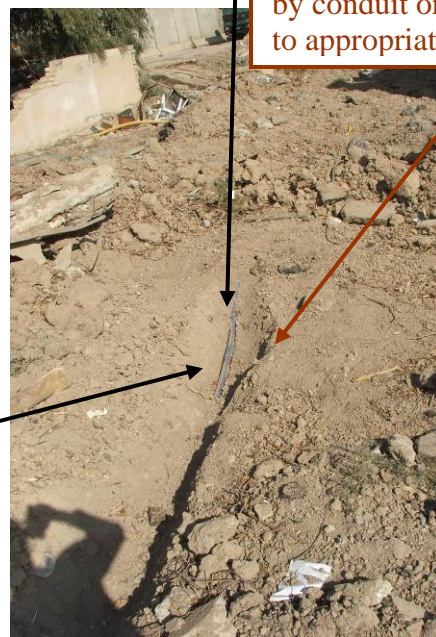
Further, the contractor poorly connected the electrical power wires to the pump station. From the power source to the base of the manhole, the electrical power wires were not placed in a conduit nor were the buried wires placed an appropriate depth under ground (Site Photo 165). At the time of the visit, the pump station appeared to be full of test water (Site Photo 166). BPC representatives stated the USACE GRD had informed them that the new pump station was currently ready for use. However, it did not appear to us to be operational. On 19 December 2006, we met with BPC representatives who stated the new pump station did not work because the contractor had not installed the correct type of pump. A pump which grinds the sewer solids had not been installed as necessary in order for the pump station to be operational. Consequently, the range administration building, a \$1.2 million facility, which the USACE GRC stated was ready for occupancy in June 2006, still could not be used.

Site Photo 165. Exposed electrical power lines to pump station

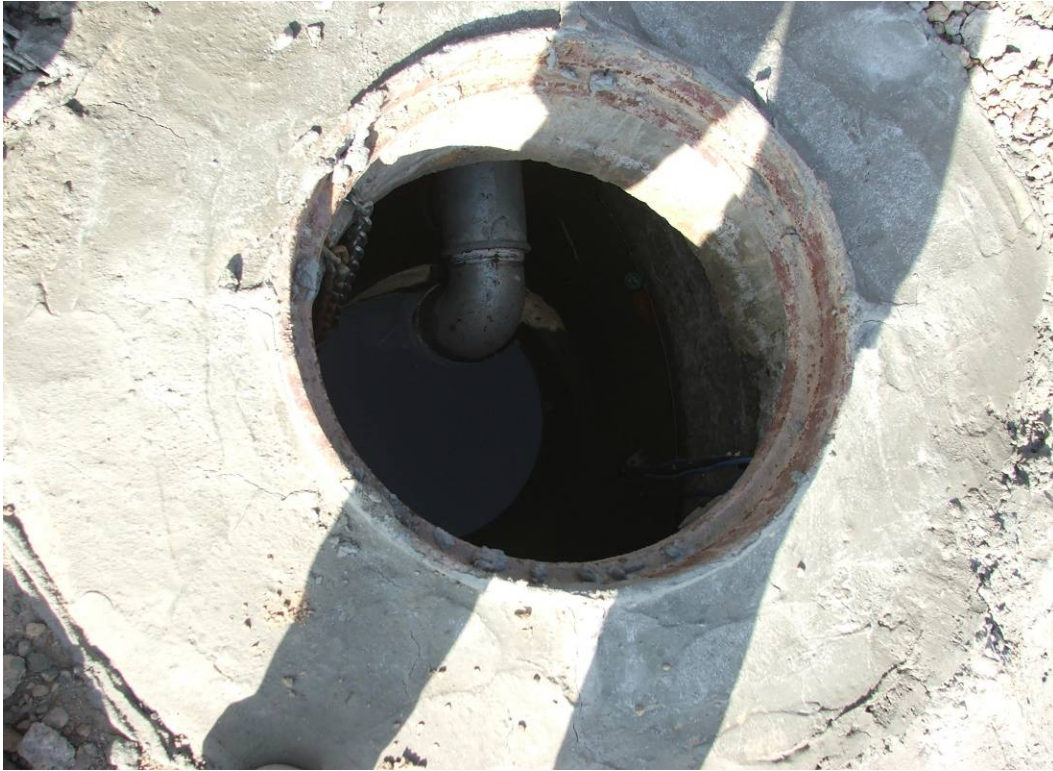
**Site Photo 166. New constructed dual pump station, which is not operational due to the installation of the incorrect type of pump**

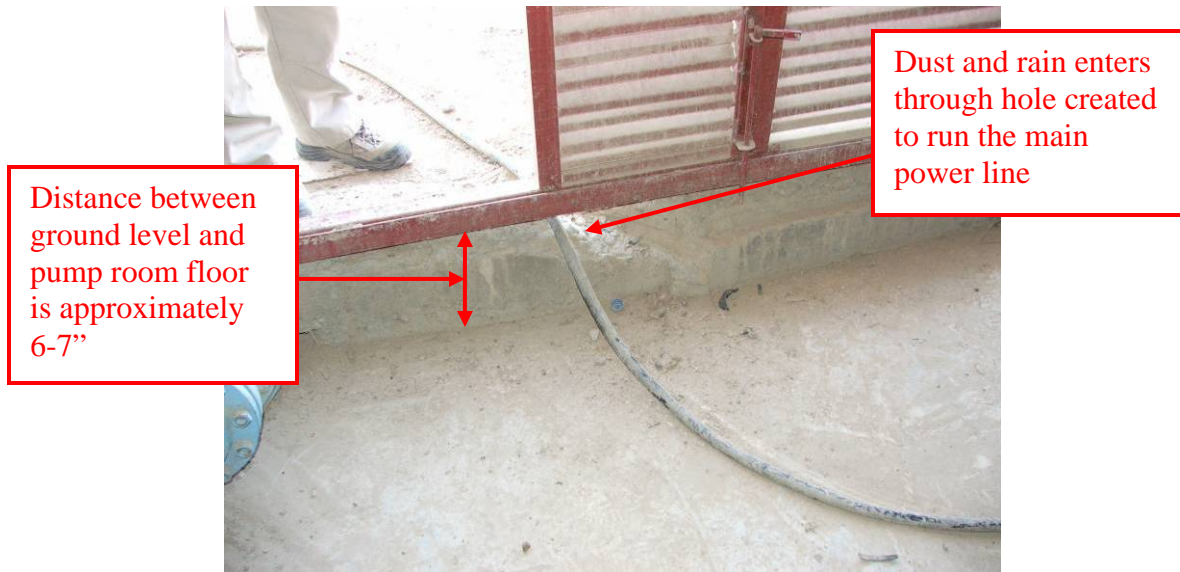
We observed limited operation of the water storage tank, which appeared to be functional. However, access to both the control room and to the top of the tank for operational functions is not adequate. The control room supporting the critical operation of this tank is below normal ground level, increasing the potential of heat, dust, and rainwater entering the room (Site Photo 174). During our site visit, we found the pump room to be extremely dusty and dirty; specifically the floor and pumps (Site Photo 175). In addition, we found the electrical wires on the pump room floor (Site Photo 176). During the rainy season, the likelihood of water entering the room through the hole for the power cable and ruining the electrical wires is exponentially increased. We did not observe any floor drains or pumps to remove water from the control room. Finally, with the pump room floor approximately 6-7" below ground level, it will be extremely difficult to keep the room clean.

**Site Photo 174. Pump room is below the college ground level**

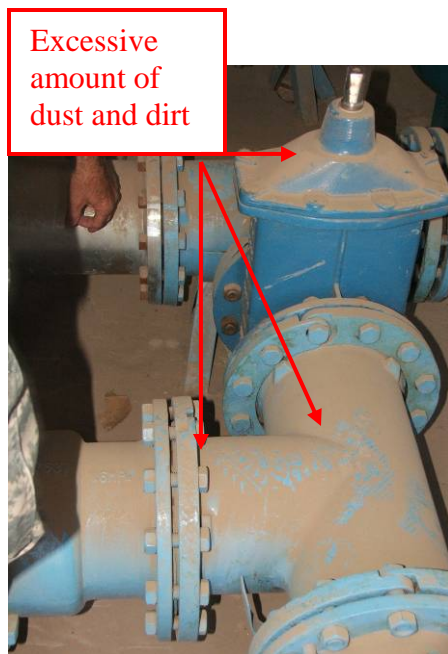
**Site Photo 175. Dirt within the pump room**

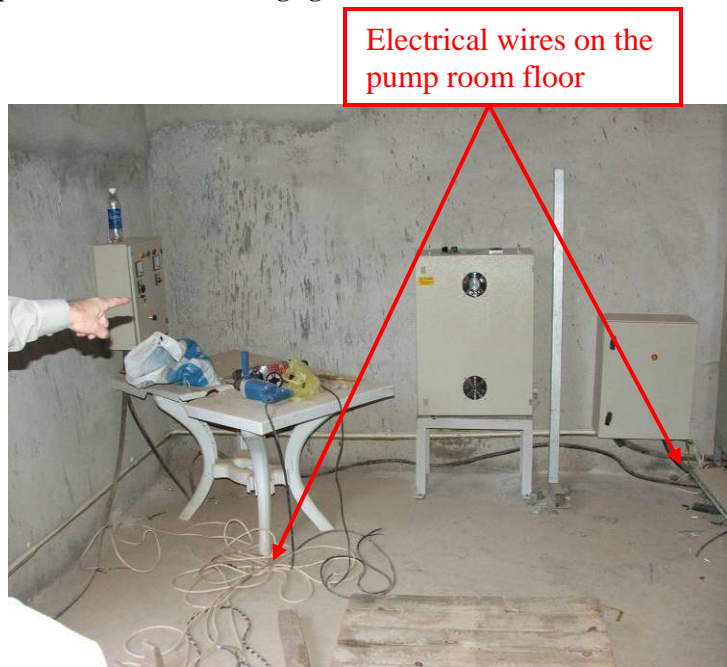
We were unable to inspect the entire plumbing and electrical systems, but they appeared to be in place. The main power supply cable was brought into this room by punching a hole under the door frame and was left on the floor to energize the pumps, motors, and control panel. We also noticed the cables providing signals to the pumps, motors, and valves from the control panel on the floor. In the event of water entering the pump room, there is the potential for significant damage to the support equipment, high pressure water main, and power generator. This would lead to a cutoff of water to the entire BPC campus for an extended period of time for repairs.

**Site Photo 176. Electrical wires on the ground**

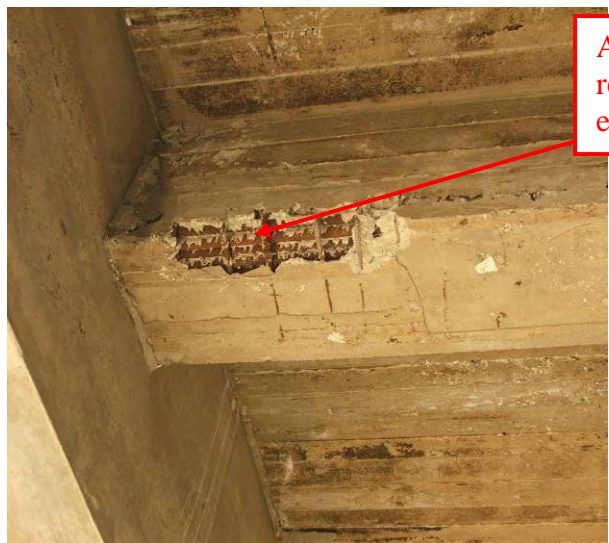
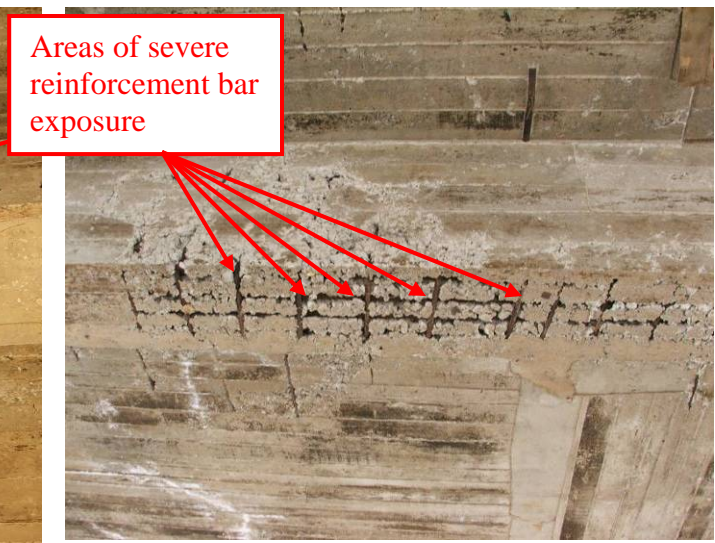
- areas of severe reinforcement bar exposure on the surface of the load-bearing reinforced concrete ceiling beams (Site Photos 178-180)
- areas of severe concrete segregation, honeycombing, and voids (Site Photos 181-183)
- poor quality brick masonry workmanship (Site Photos 184-187)

**Site Photo 179. Reinforcement bar exposure**

**Site Photo 180. Reinforcement bar exposure**

- Inadequate concrete cover for reinforcing steel and improperly embedded electrical conduit “potentially lends to spalling, de-lamination and reinforcing steel corrosion, which ultimately could cause structural failure.”
- Inadequate cover for reinforcing steel may “create a condition in which the reinforcing steel is subject to corrosive action from the humidity and chemical-use associated with laundry facility operations. Potential corrosion of the re-steel may lead to slab inability to bear roof load and eventual structural failure.”

- removing the existing concrete slab, performing the column and beam repairs, preparing the forms, and completing the elevated concrete placement
- considering a new truss design

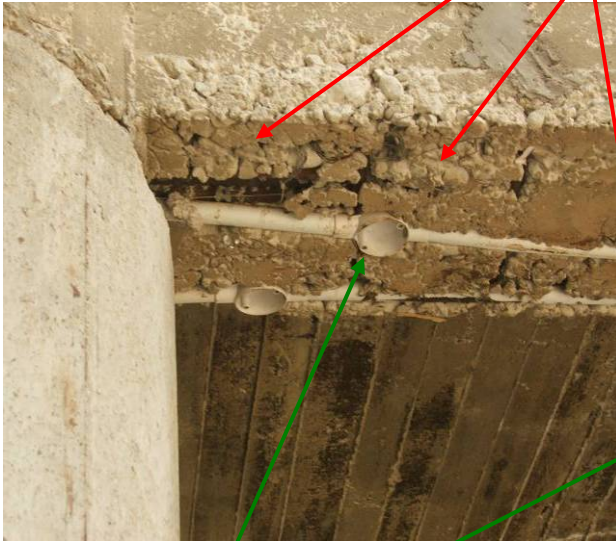
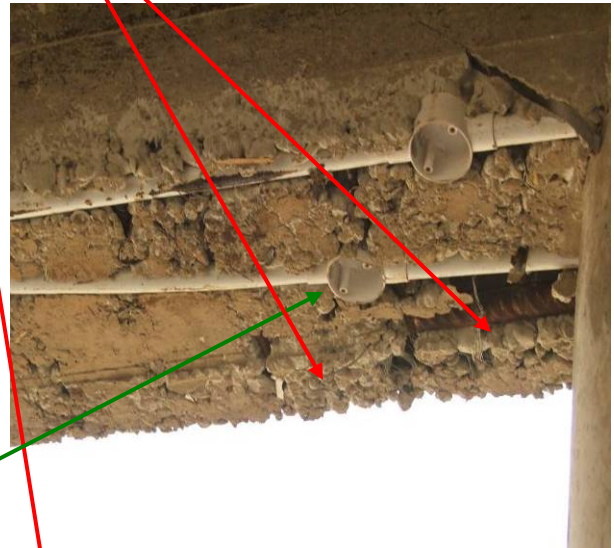
**Site Photo 181. Concrete segregation and electrical conduit exposure**

**Site Photo 182. Concrete segregation and electrical conduit exposure**

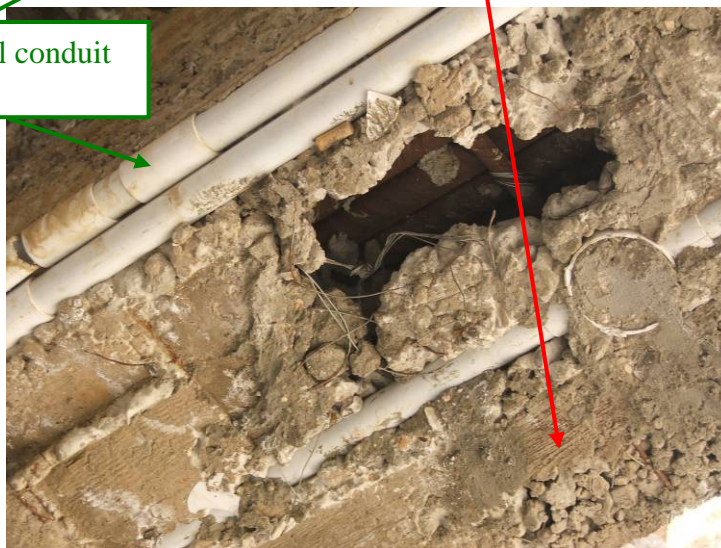
**Site Photo 183. Concrete voids and electrical conduit exposure**

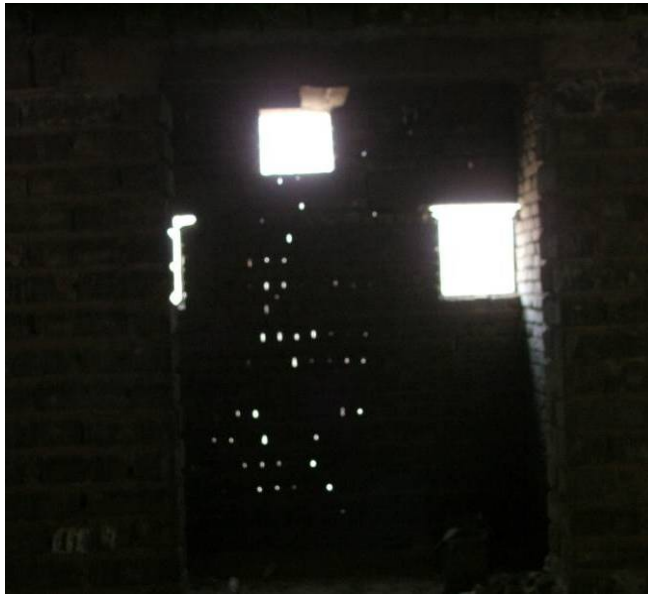
**Site Photo 184. Sunlight passing through gaps in wall**

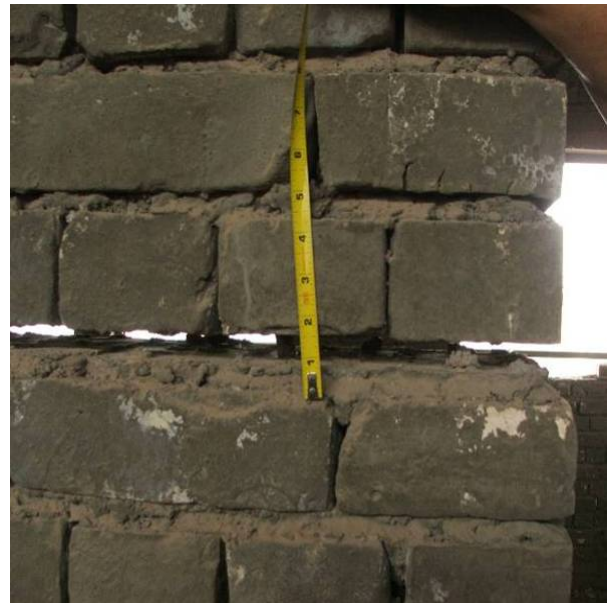
**Site Photo 185. One inch gap between bricks**

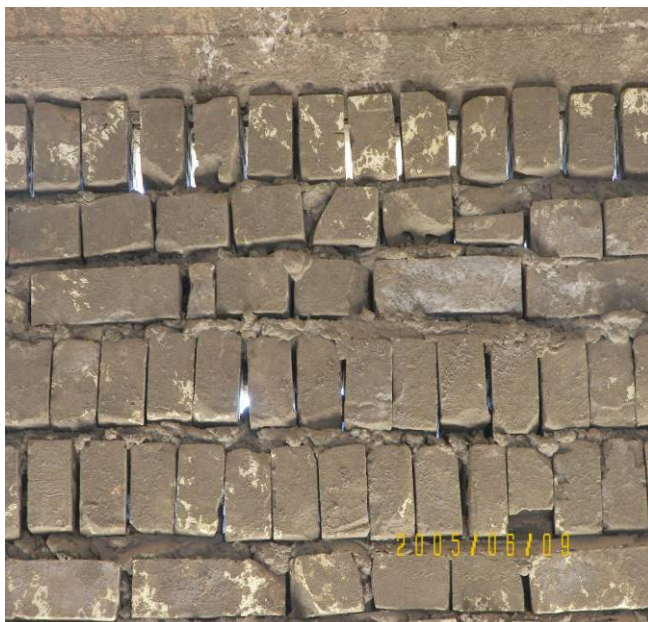
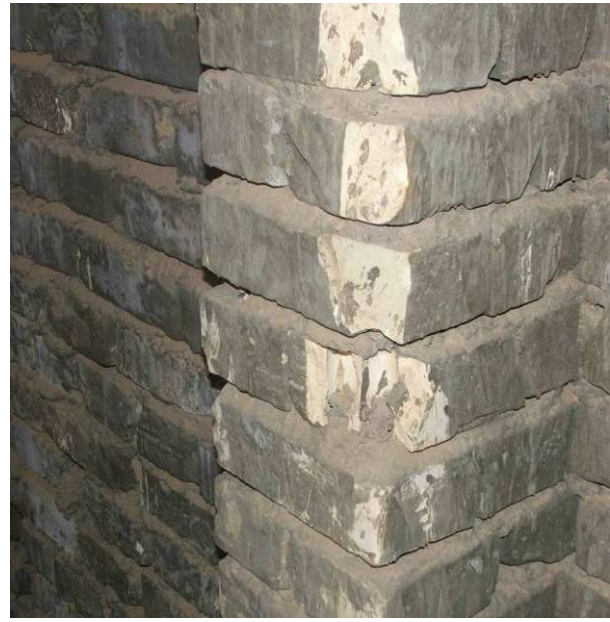
**Site Photo 186. Example of poor brick workmanship**

**Site Photo 187. Example of poor brick workmanship**

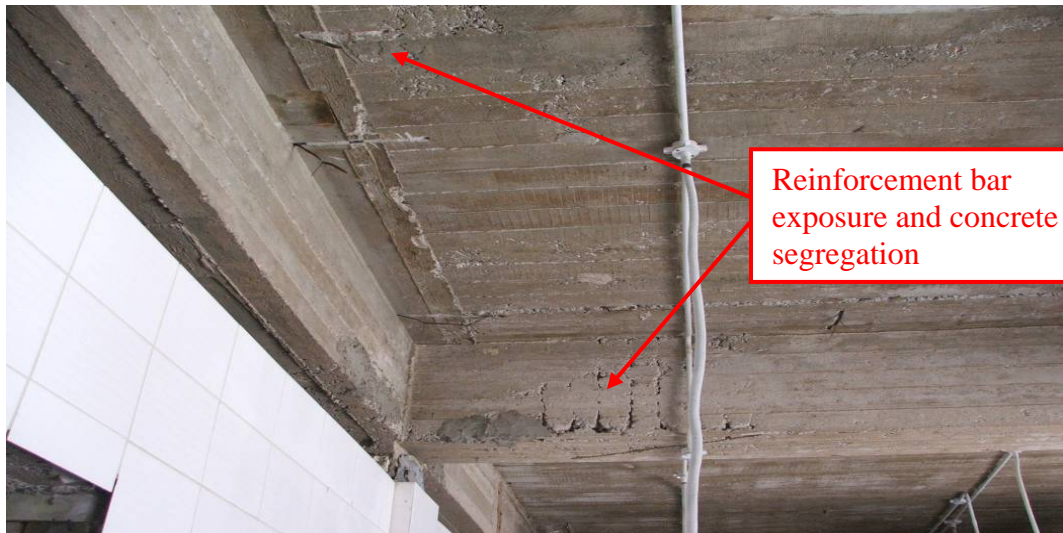
We viewed the dining facility in the condition it was left by Parsons – MNSTC-I’s contractor had not begun working on the facility. According to the design drawings, the dining facility was to be a single-story building with main seating area, male and female toilets, cashier areas, serving counter, staff room, and receiving area. However, the as-built drawings clearly state the size of the main seating area was sufficient for 1,440 people, not the 1,500 required by the TO. We verified that the floor and wall construction, and partial ductwork and electrical work had been completed (Site Photos 189-191). Parsons’ subcontractor left equipment and materials on site after the project was de-scoped (Site Photo 192). The new subcontractor will use the leftover material. We identified areas of reinforcement bar exposure and concrete honeycombs and segregation (Site Photo 193).

**Site Photo 193. Construction deficiencies within the indoor dining facility**

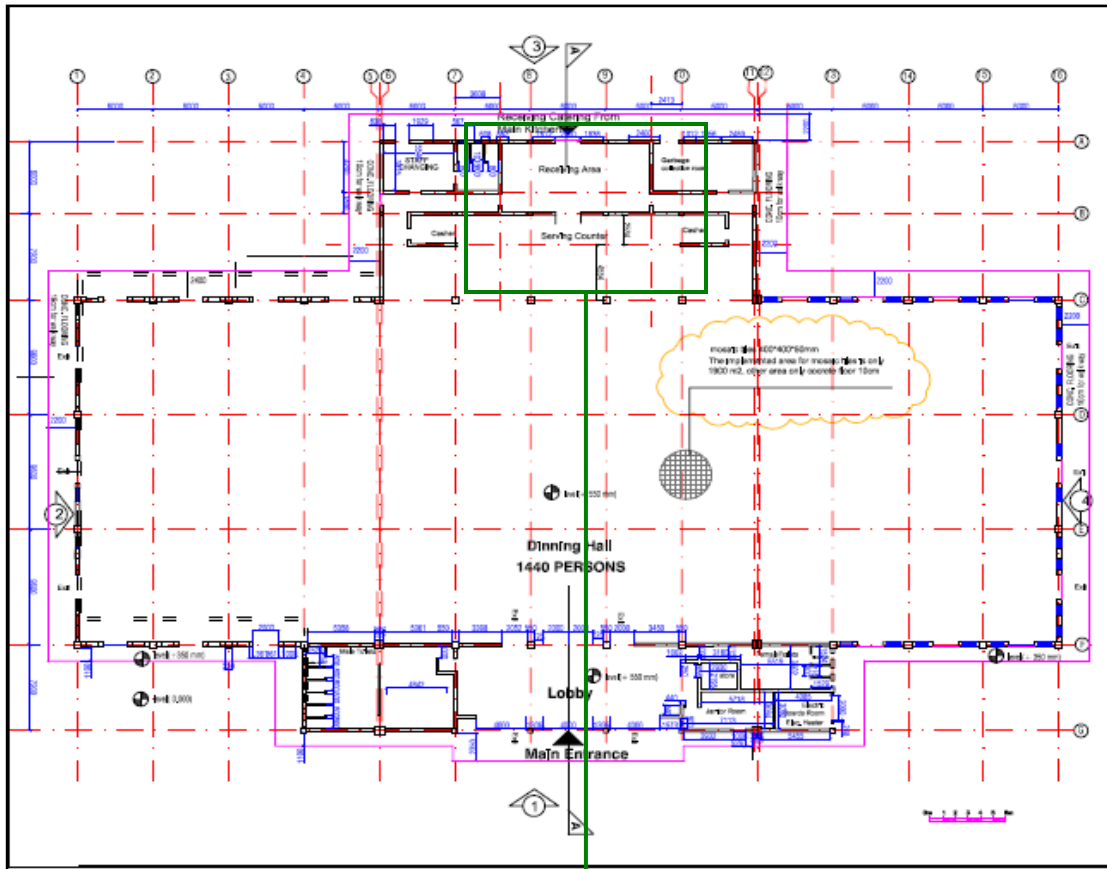
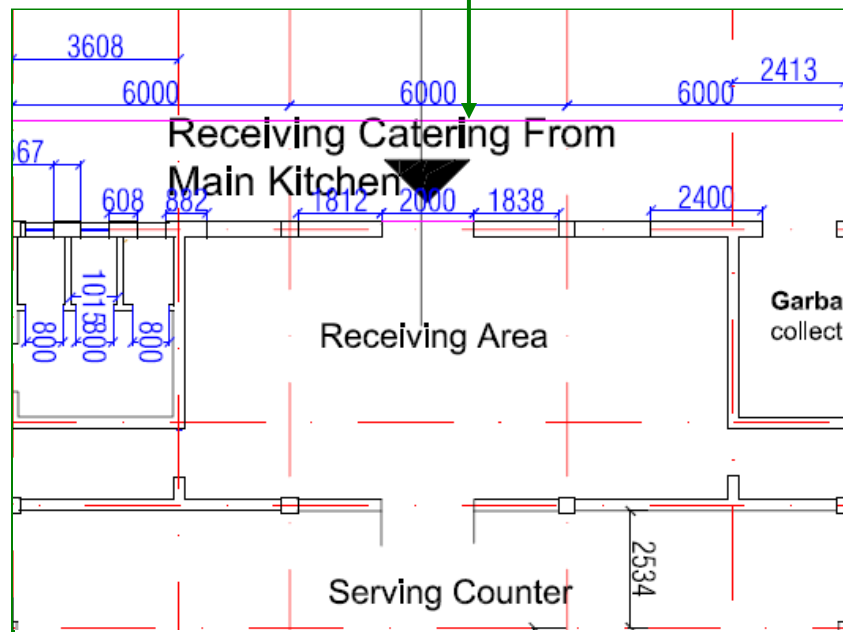
include the “attached” kitchen required by the TO. The government representative who reviewed Parsons’ design submittals did not mention the complete omission of the attached kitchen. GRD representatives, including the QAR did not realize the omission, either. GRD representatives believed the small room attached to the dining facility was the kitchen; however, this room is actually the receiving and servicing area for the dining facility (Site Photo 194 and Figures 14 and 15). No comment or clarification regarding this issue was raised at the time of design review. When the dining facility is completed, food will have to be brought in from the existing kitchen located on the BPC grounds. GRD representatives are now attempting to locate funding to construct a kitchen for the dining facility.

Figure 14. As-built drawing for the dining hall with no attached kitchen

Figure 15. Enlarged view of the area GRD thought was the attached kitchen, which turned out to be the receiving area

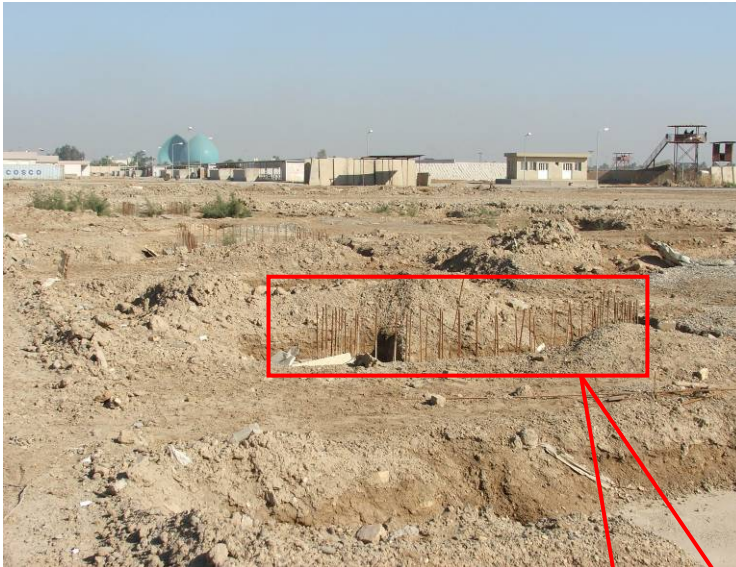
TO 06 required the construction of a physical training (PT) field, complete with pull-up bars, mats, etc. According to BPC representatives, the PT field was excavated and a foundation with reinforcement bars was partially completed. GRD officially de-scoped this project and it was not completed. The foundation was partially covered with dirt; however, a portion of the reinforcement bar still extends beyond the dirt covering (Site Photos 197 and 198). BPC representatives are concerned about the safety of its cadets and instructors, specifically a cadet/instructor tripping over an exposed reinforcement bar and impaling himself. When GRD de-scoped this project, the responsibility for correcting the potential safety hazard of exposed reinforcement bars transferred from Parsons and GRD to the BPC officials.

**Site Photo 197. Foundation for PT field with exposed reinforcement bars extending beyond the ground**

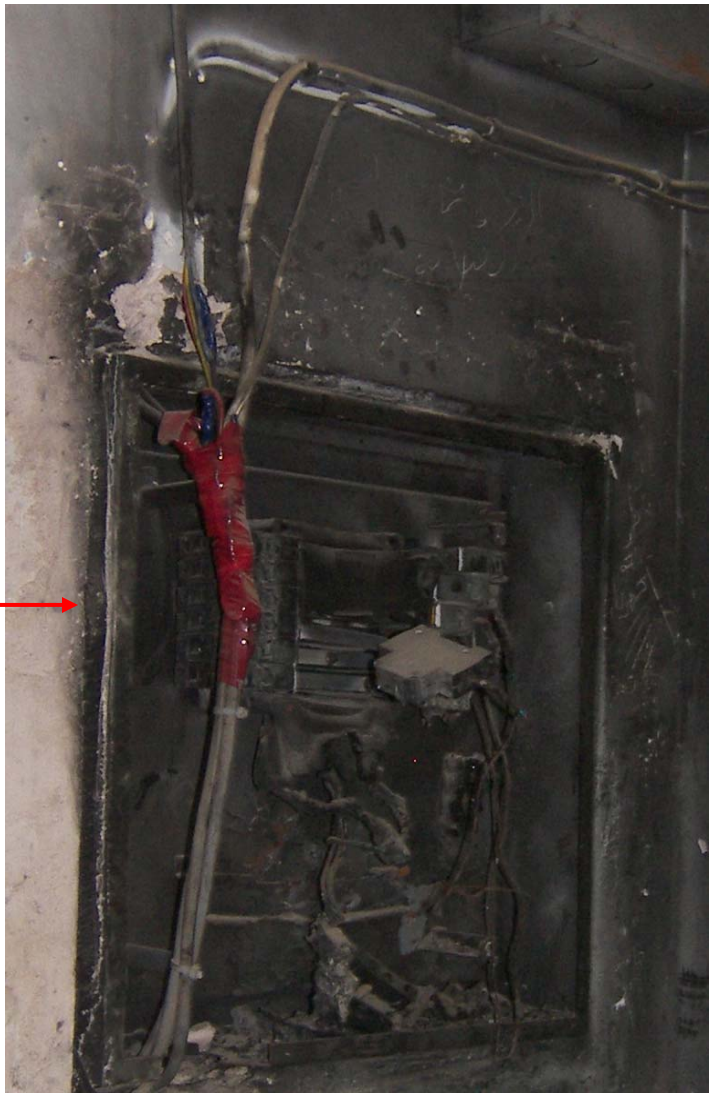
We observed old multiple service lines connected to the existing main power feed without any required power panel or circuit breakers. Circuit breakers provide safety to people and equipment by offering the opportunity of a mechanical shut down from the surge in incoming power as well as over loading the branch circuit. However, the safety and appropriateness of the electrical work is questionable. For example, the contractor failed to use a circuit breaker and instead wired the incoming heavy amp line directly to the lower amp lines, which significantly increases the chance of an additional electrical fire.

**Site Photo 200. “Emergency” electrical work performed by Parsons**

**Site Photo 201. Close-up view of Site Photo 200.**

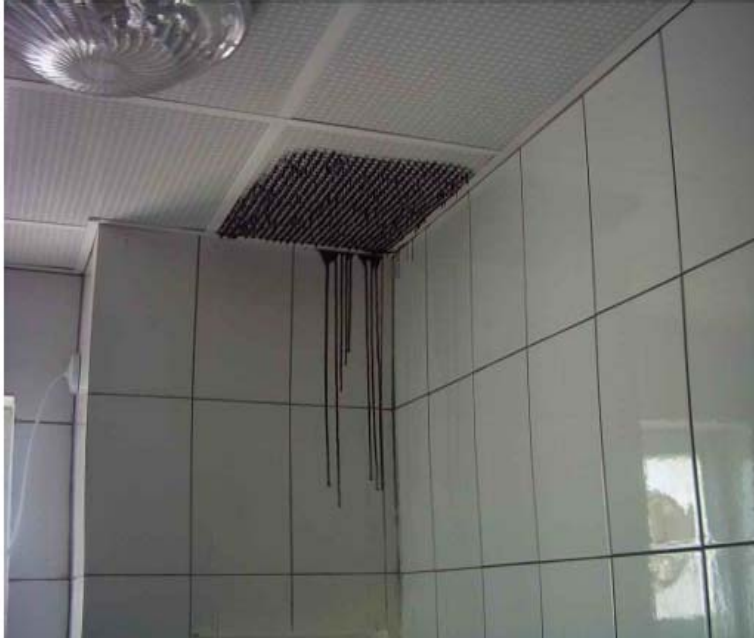
The results of the assessment report documented the “improper installation of roof flooring” for all classroom buildings, range control building, library, instructor barracks, language instructor barracks, forensic lab building, workshop building, and motor pool building. Specifically, “most of the roof mastic areas need to be repaired, maintained and corrective action must be taken to slope the concrete tiles [and] the drain openings.” GRD representatives confirmed that the roofs were poorly constructed for most BPC buildings. Poor mastic work is shown in Site Photo 202; while the end result of the poor work is shown in Site Photos 203 and 204.

**Site Photo 203. Interior damage caused by leaking tar**

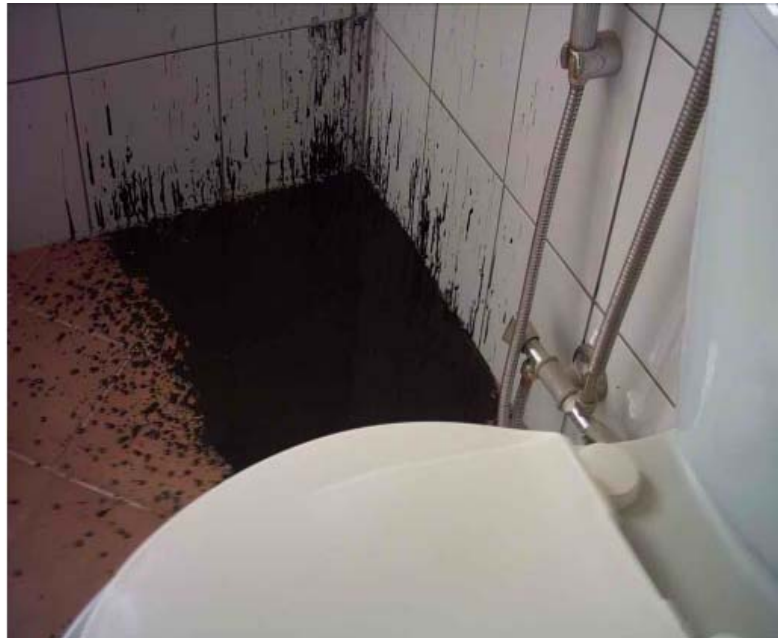
**Site Photo 204. Interior damage caused by leaking tar**

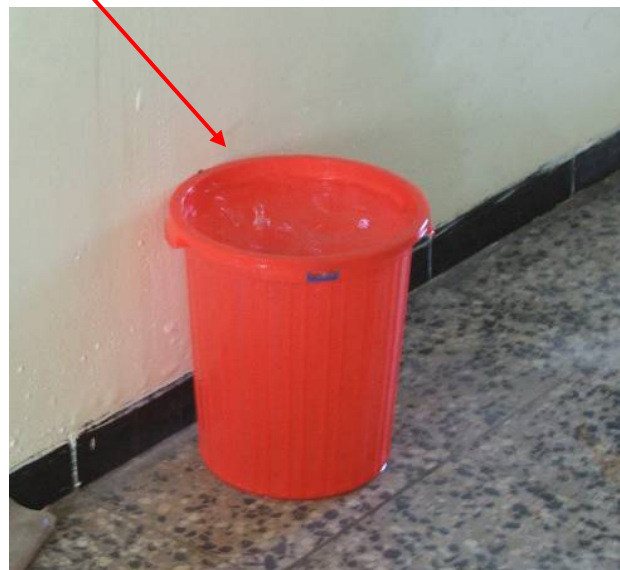
We visited the BPC on 10 November 2006 to verify the work accomplished on the cadet barracks buildings. We immediately noticed water on the ground floor common area (Site Photo 205). We observed water leaking from the ceiling (Site Photos 206 and 207) at approximately the same pace as documented in our previous report. We also noticed leaking water in the same locations on the pipes (Site Photos 208 and 209). [NOTE: the waste water damage to the current pipes is less than the damage from our original site visit; however, the current pipes had only been used for a few weeks.] BPC cadets stated the water had been leaking for approximately 4-5 days by the time of our visit. The cadets put a bucket under an open section of the false ceiling to capture leaking water (Site Photos 210 and 211).

**Site Photo 211. Close-up of bucket full of leaking water**

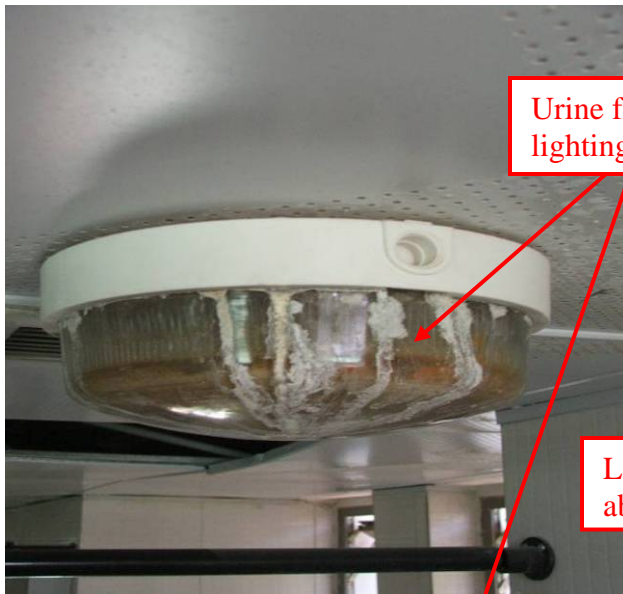
We continued our visit to the barracks first floor bathroom where we found more evidence that the subcontractor had not properly corrected the previously identified plumbing deficiencies. In some instances, it does not appear the subcontractor even replaced ceiling lights and false ceiling panels (Site Photos 212-215). Several ceiling lights were full of urine and fecal matter and corroded on the outside, which appeared to be more than a few weeks old; while the crystallized urine stains on the false ceiling panels appeared to be similar to the panels that were seen on our first visit to the BPC. However, BPC representatives were told by the GRD and the subcontractor that the entire barracks were complete. Not only were the upstairs bathrooms not complete, in some cases, potential hazards existed. For example, above the showers, live wires are dangling through exposed areas of the false ceiling with light fixtures filled with urine and water leaking from the sewer pipes (Site Photos 216 and 217).

**Site Photo 212. Urine-filled ceiling light**

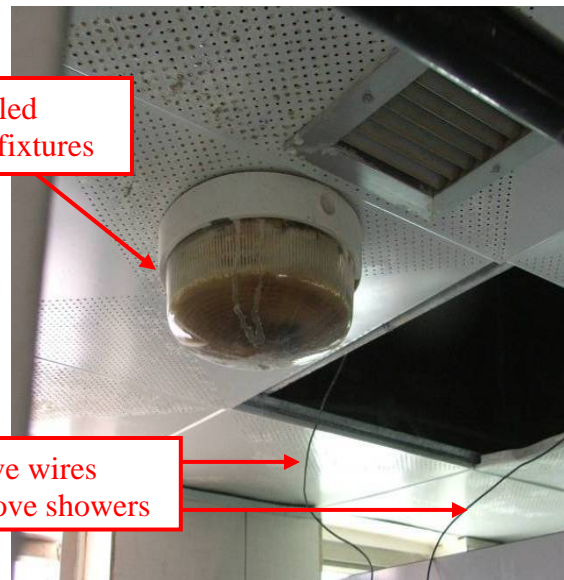
**Site Photo 213. Urine-filled ceiling light and live wires**

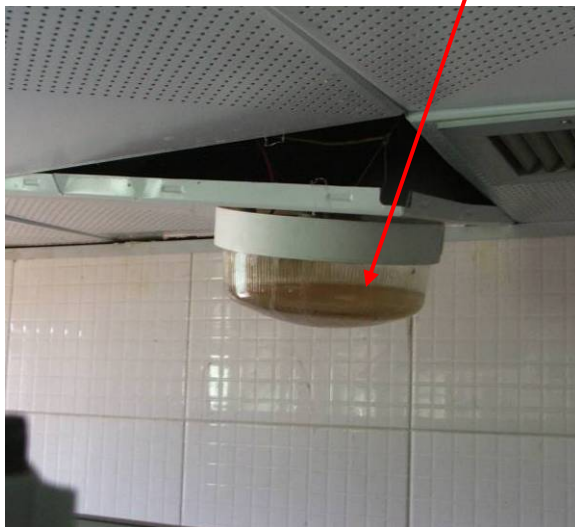
**Site Photo 214. Urine-filled ceiling light**

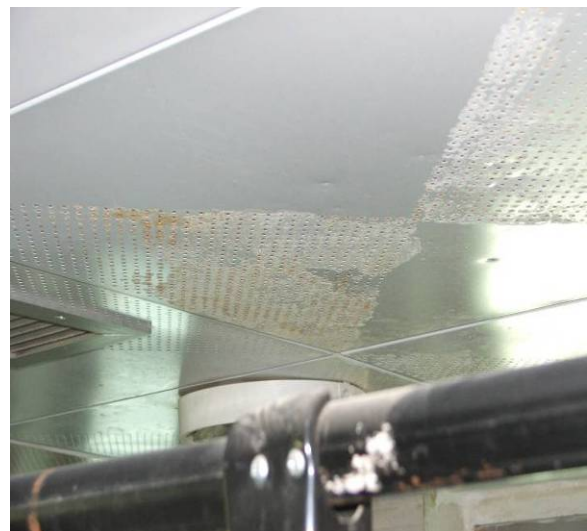
**Site Photo 215. Crystallized urine stains on ceiling panels**

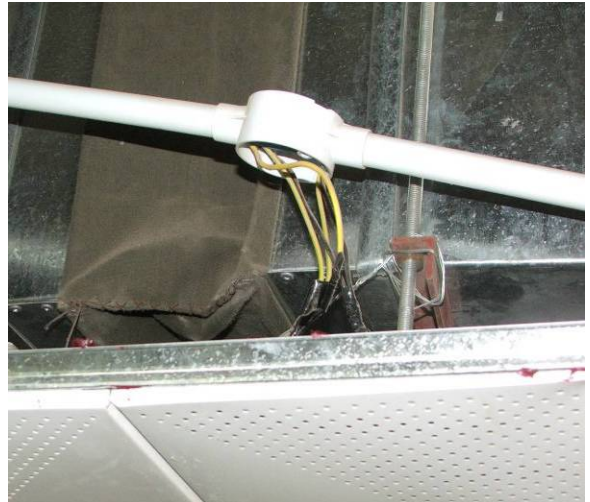
**Site Photo 217. Wires taped together**

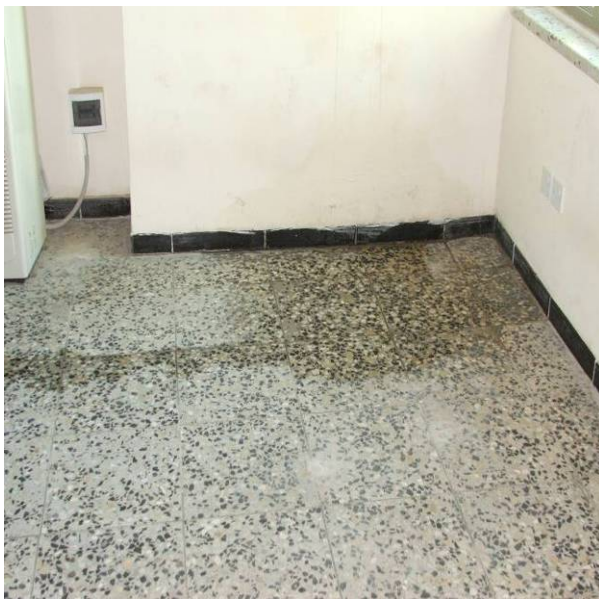
In another barracks building, we identified water leakage on a smaller scale than the previous barracks building. However, we noticed damage from the water leakage on the floors (Site Photos 218 and 219), walls, doorframes, and doors (Site Photos 220 and 221).

**Site Photo 218. Water damage on the floor of the cadet barracks**

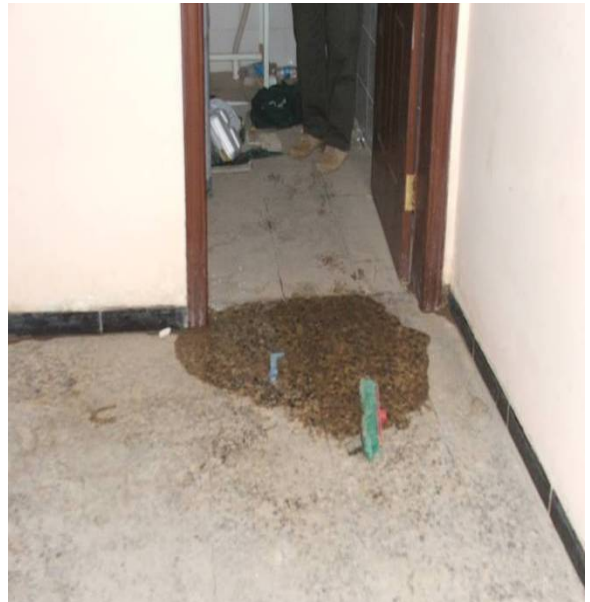
**Site Photo 219. Additional water damage in cadet barracks**

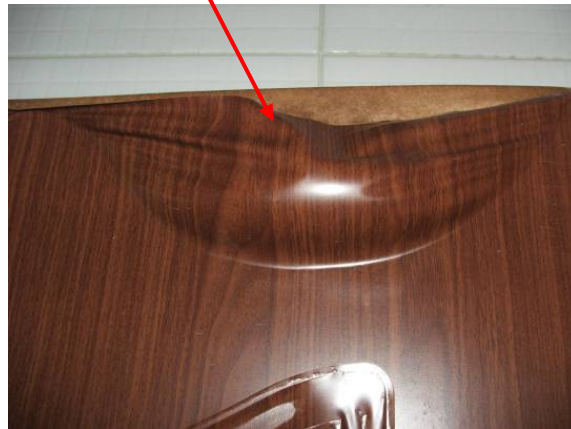
**Site Photo 221. Enlargement of Site Photo 220**

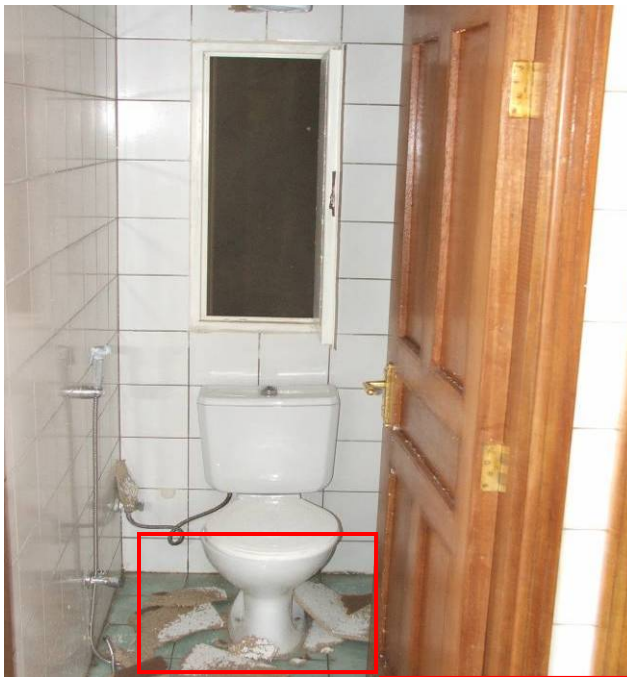
Earlier in this report, we documented damage from water leakage, poor door installation, and the ground floor sloping downward to the right in Classroom Building E. We visited Classroom Building E on 10 November 2006 to review the work completed by the subcontractor. The plumbing issues in the male bathroom appeared to have been corrected; however, in the female bathroom we witnessed evidence of water leakage on the false ceiling panels (Site Photo 222) and where the false ceiling panels collapsed and sent debris and water to the floor (Site Photos 223 and 224).

**Site Photo 223. Damaged ceiling panels that fell to the ground**

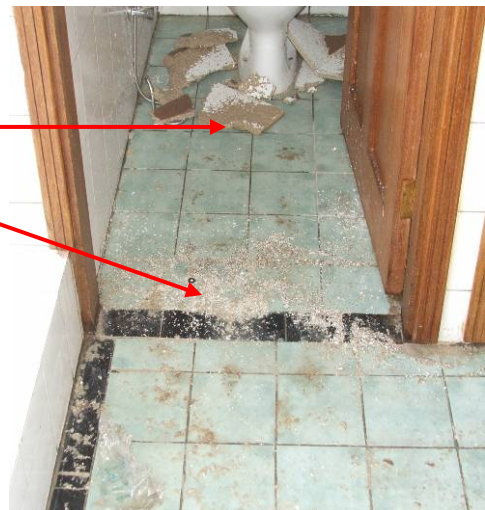
**Site Photo 224. Close-up of Site Photo 223**

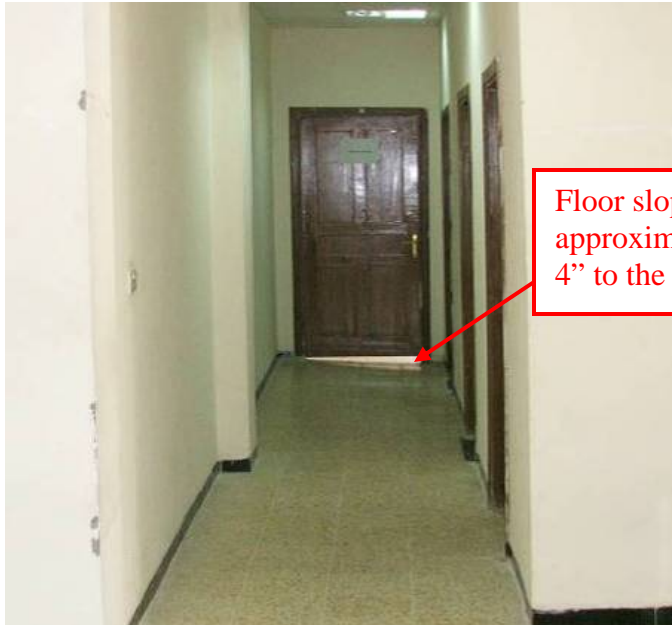
The subcontractor replaced the ground floor to correct the downward slope earlier identified (Site Photos 225 and 226). The new floor did not have the significant downward slope; however, the subcontractor did not correct the poor doorframe installation. The doorframe was originally constructed when the floor sloped and no corrective actions were taken to adjust the doorframe. Consequently, the door does not properly shut (Site Photo 227).

Floor sloped  
approximately  
4" to the right

**Site Photo 225. View of sloped floor in Classroom E**

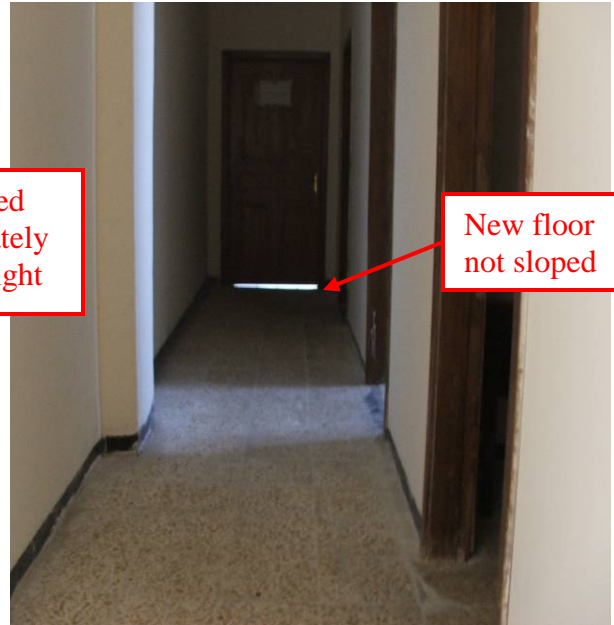
New floor  
not sloped
